ARMORED FORCE MEDICAL RESEARCH LABORATORY

CARBON MONOXIDE HAZARD FROM AUXILIARY GENERATORS IN TANKS

Project No. 3-12

December 20, 1942

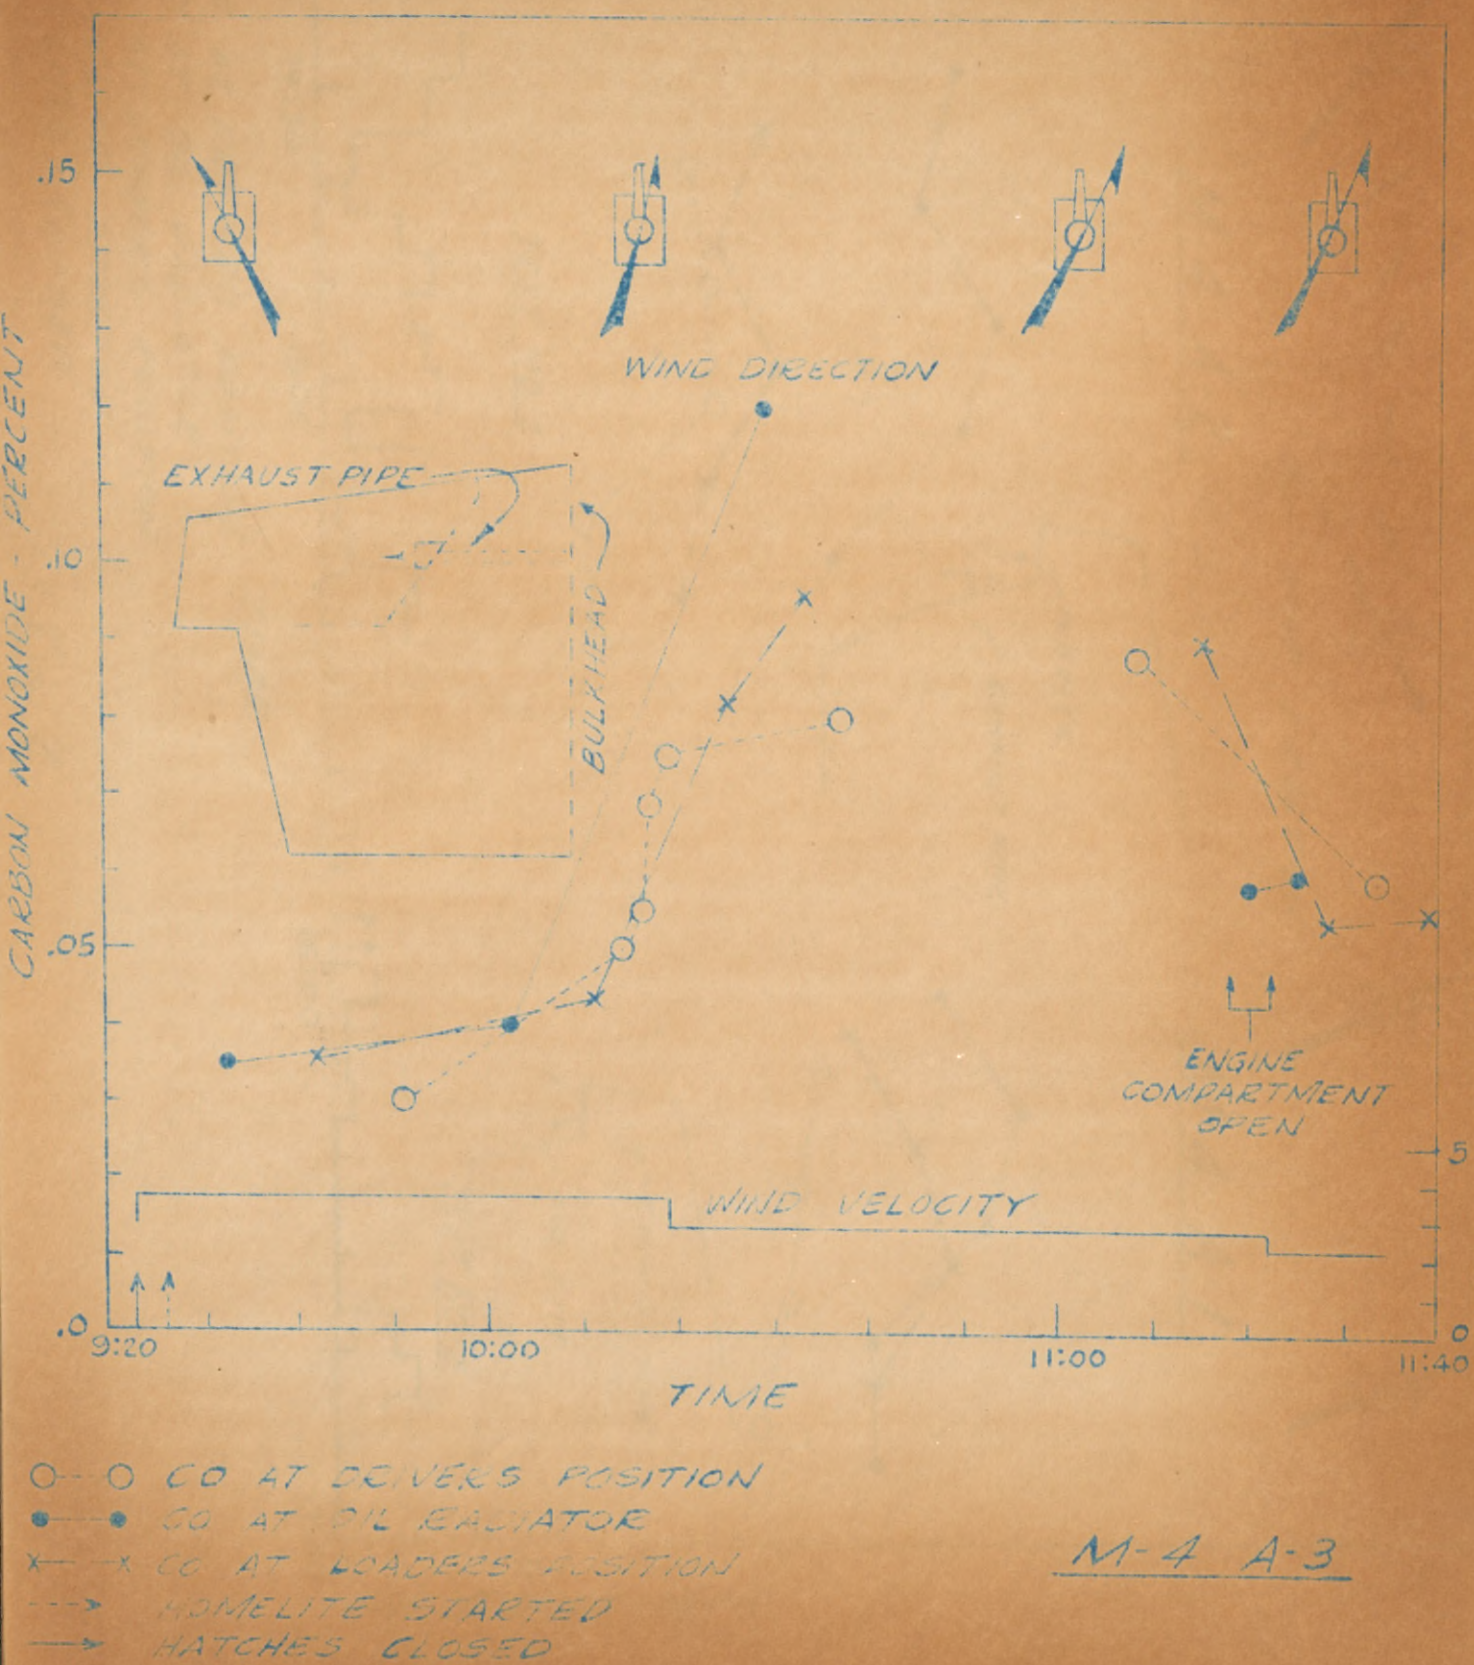
Fig. 1

M4A3 ---- with exhaust pipe terminating within the engine compartment. (Fig. 1)

a. M4A3. Carbon monoxide concentrations are shown in Fig. 1. Concentrations were highest at the radiator, but were found to be greatly in excess of permissible levels in the bow. There was a rapid distribution of the contamination within the tank, with concentrations ranging, during the test, from 0.03 to 0.10 percent carbon monoxide.

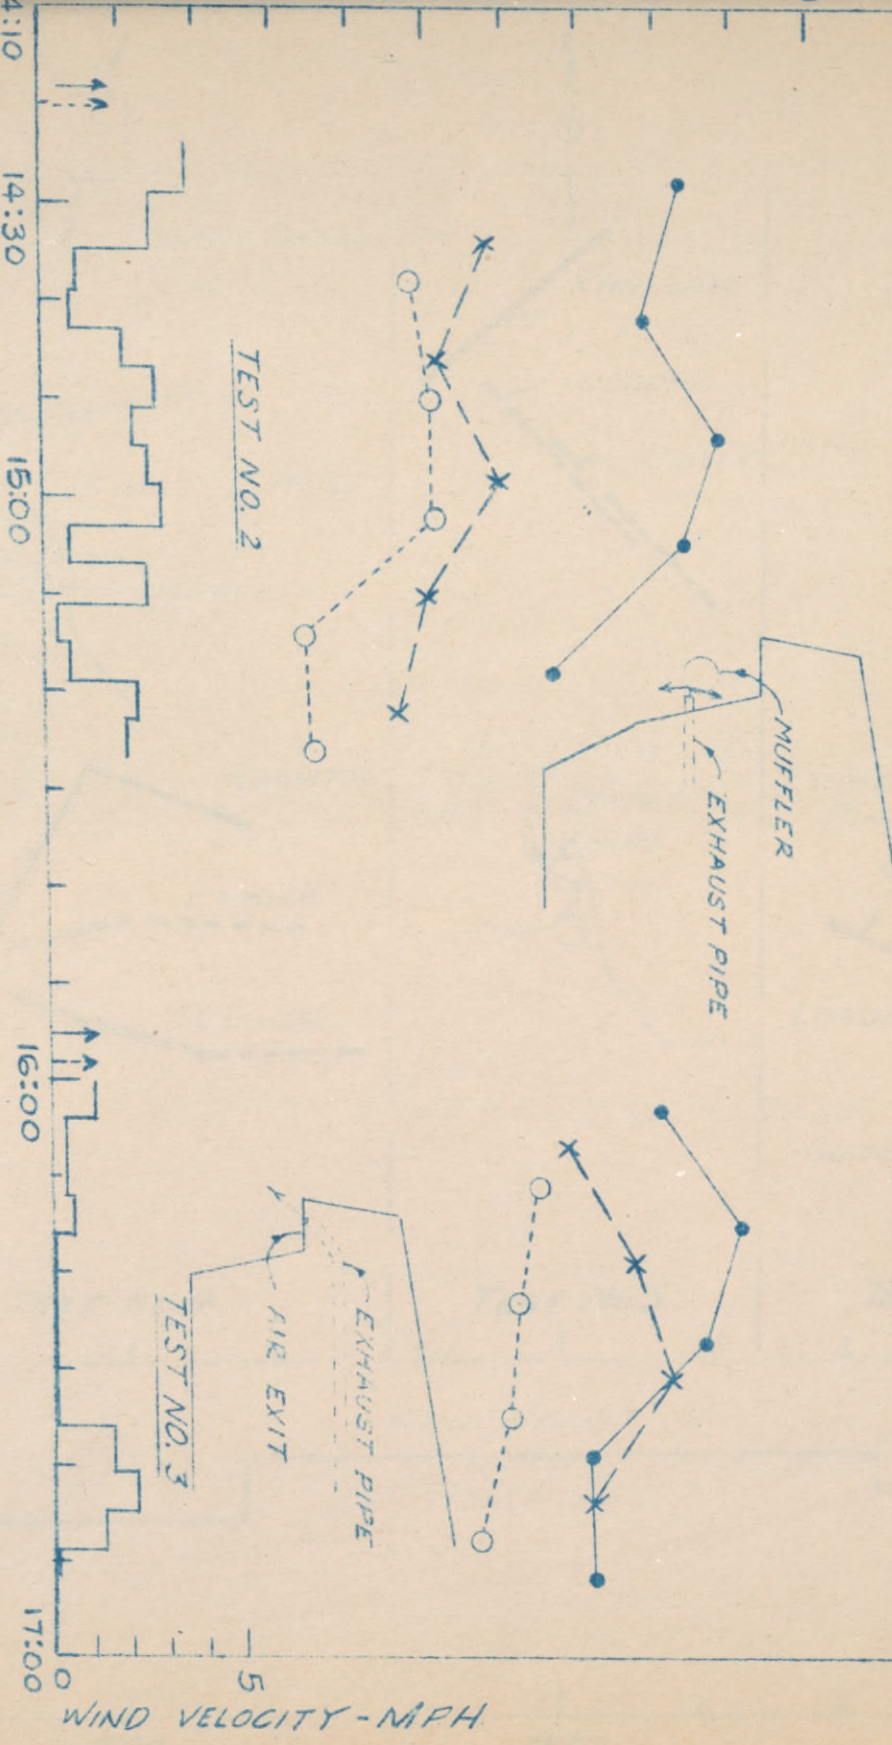
Fig. 2

M4A1 ---- with exhaust pipe terminating in the air-exit area at rear of tank. (Fig. 2)

M4A2 ---- with exhaust pipe terminating outside the rear wall of the engine compartment and between it and muffler. (Fig. 2)

b. M4A2. In this model the exhaust pipe passes through the engine compartment and terminates outside between the rear wall and the muffler. The latter acts as a baffle which deflects the exhaust gases, some of which rise and return into the engine compartment through the main engine radiator and thus find their way back into the fighting compartment. Carbon monoxide concentrations at the three sampling locations are all shown in Fig. 2. The ranges in concentrations under the conditions of test were:

1. Radiator: 0.065 to 0.087 per cent carbon monoxide
2. Loader : 0.045 to 0.060 per cent carbon monoxide
3. Driver : 0.035 to 0.052 per cent carbon monoxide

c. M4A1. The exhaust pipe in this case terminates just inside the armored air-exit opening at the rear of the engine compartment, discharging at a downward angle through the screened opening. Under conditions of a tail wind, the exhaust gases are trapped to a considerable degree and return through the engine compartment to the fighting compartment. Carbon monoxide concentrations are shown in Fig. 2. Ranges in concentrations were:

1. Radiator: 0.070 to 0.090 percent carbon monoxide
2. Loader : 0.067 to 0.083 percent carbon monoxide
3. Driver : 0.057 to 0.063 percent carbon monoxide

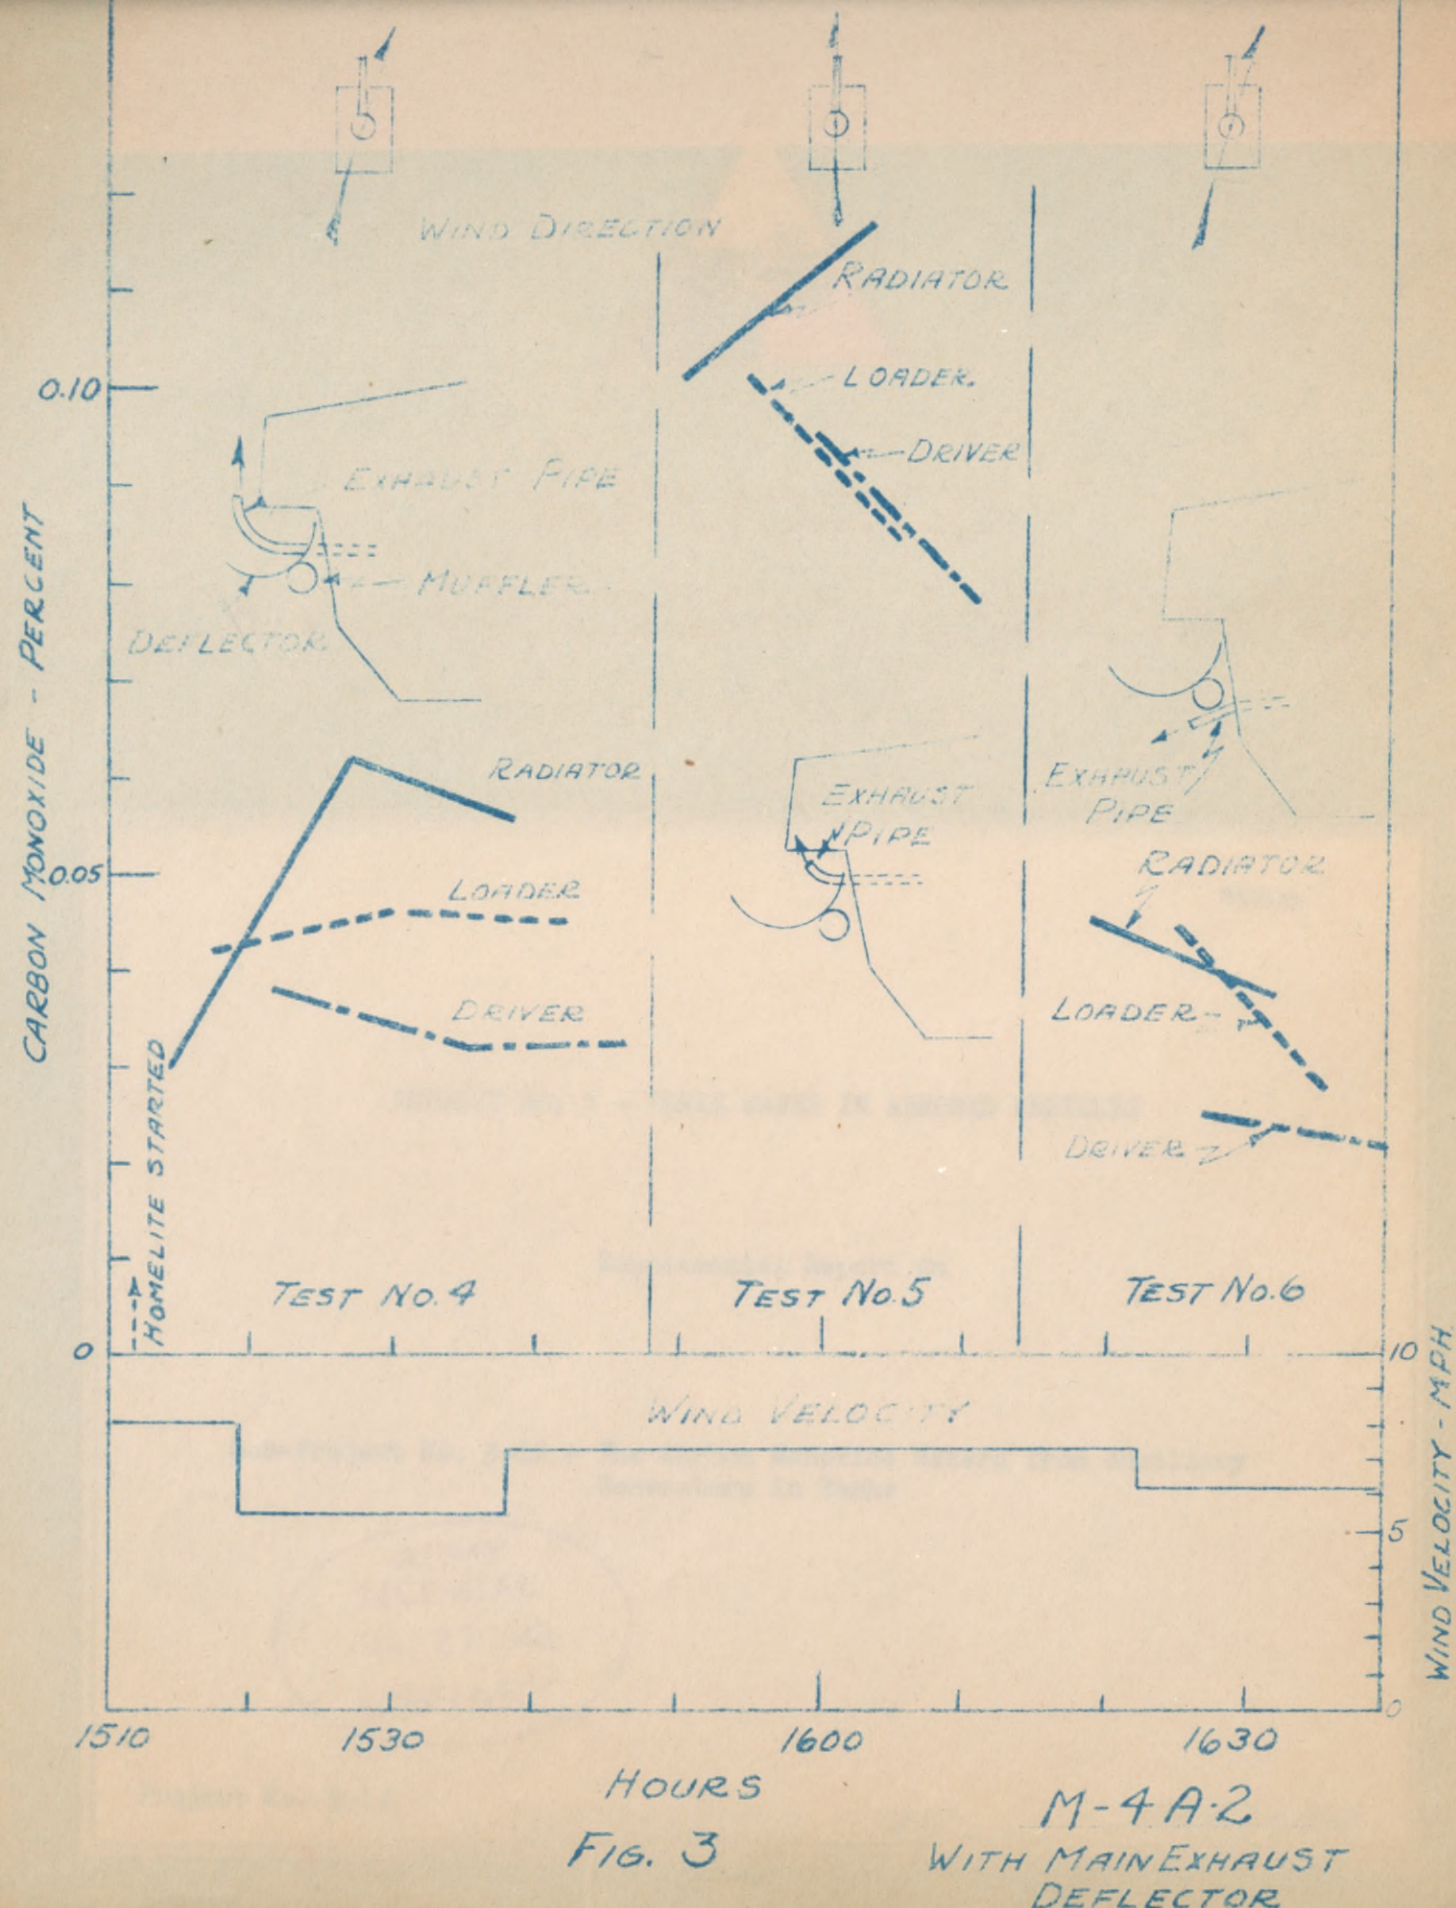
FIG. 3

M4A2 ---- with exhaust pipe terminating outside the rear wall of the engine compartment and below the curved baffle plate provided for the deflection of the tank motor exhaust gases. (Fig. 3)

For comparison, carbon monoxide concentrations were determined with the exhaust discharging above the main exhaust deflector at such a point that the gases traveled upward into the overhanging air-exit area. The results are shown in Fig. 3. With the terminal discharge beyond the overhang and in an upward direction conditions were better than in any of the standard tanks but not altogether satisfactory since some of the gas spilled over the top of the engine compartment and down through the main air intake into the fighting compartment. This shows that correction of the situation is not merely a matter of extending the exhaust pipe out through the rear wall. It must discharge finally at a point where there is little possibility of its being carried back into the tank. It is believed that the preferable location is near the bottom of the tank and to one side of the rear wall.

The most favorable results were obtained with the exhaust pipe terminating beyond the rear wall and below the main exhaust deflector plate. The action of the latter was to prevent the exhaust gases from rising directly into the air-exit area at the rear of the tank. It may be concluded that with exhaust deflector plates installed on tanks, no serious problem will arise (for periods of operation of from 1 to 2 hours) with respect to the exhaust gases from the auxiliary generators when the exhaust pipe terminates below the deflector plate.

a. The exhaust pipe from the auxiliary generator should be extended outside the rear wall of the engine compartment and be terminated at a point free from obstruction so that the exhaust is not deflected toward the air intake or exit openings in the engine compartment. The best location is believed to be near the bottom and to the side of the rear wall. (Fig. 3)

b. When a main exhaust deflector plate is provided, the auxiliary exhaust should be located below it and approximately ten (10) inches from the rear wall of the engine compartment.
