PROJECT NO. 3 - TOXIC GASES IN ARMORED VEHICLES

Sub-Project No. 3-12 - The Carbon Monoxide Hazard from Auxiliary  
Generators in Tanks

April 2, 1943

CARBON MONOXIDE HAZARD FROM AUXILIARY GENERATORS IN TANKS

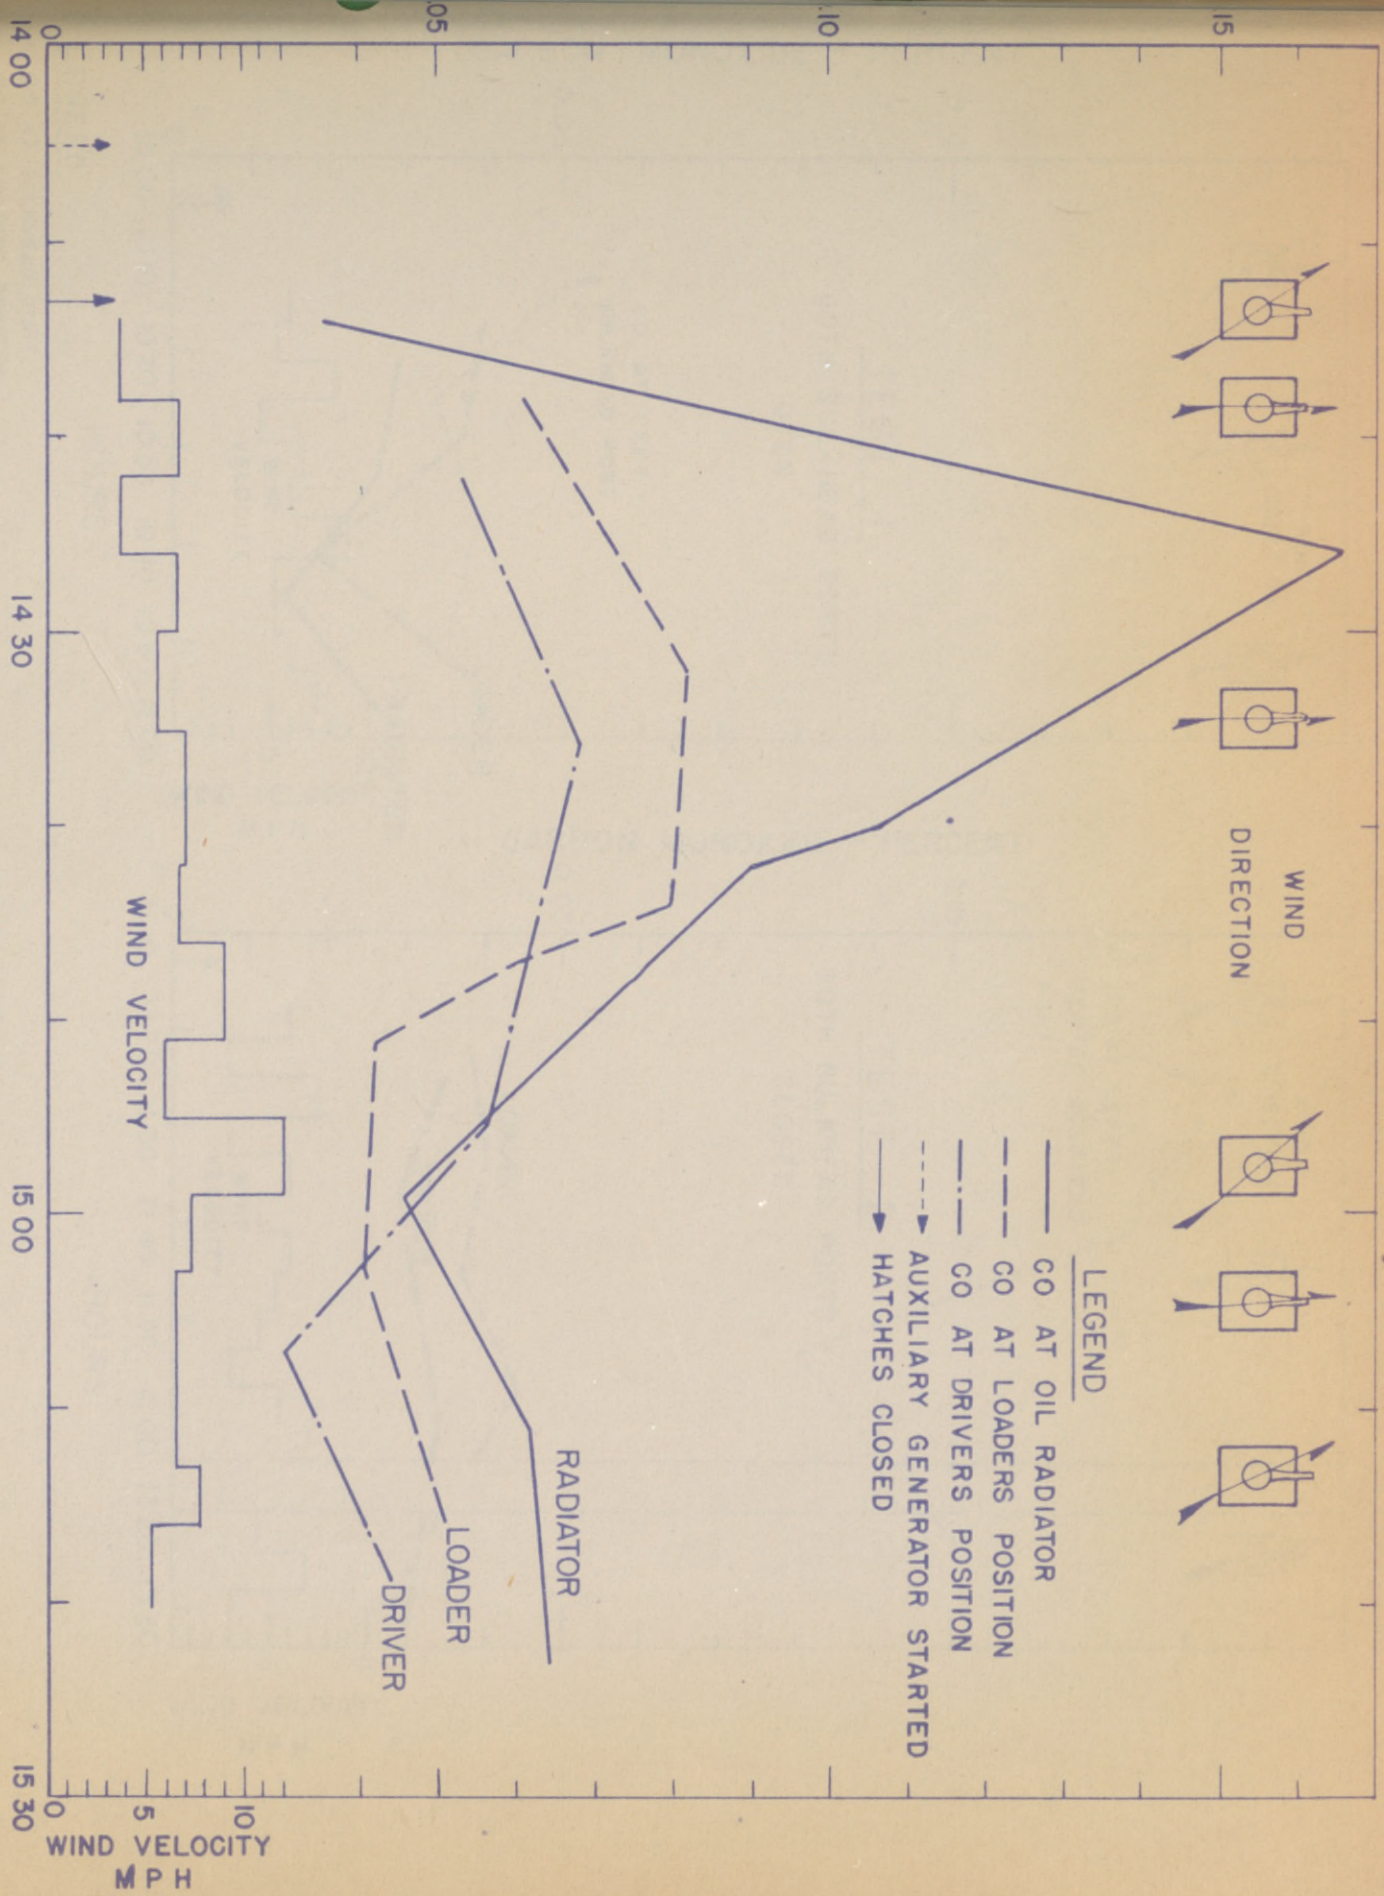
(1) Operation of the auxiliary generator in the M4A4 tank when the tank engine is not running produces hazardous concentrations of carbon monoxide in the fighting compartment. (Fig. 1)

a. Extend the exhaust pipe from the auxiliary generator in the M4A4, M5A1 and M7 tanks so as to discharge beyond the rear wall of the engine compartment, in accordance with the recommendations of the report dated December 20, 1942.

b. Construction and maintenance of the exhaust line should be adequate to prevent direct leakage of exhaust gases into the fighting compartment.

c. Whenever possible, the hatches should be open during operation of the auxiliary generator with the tank motor not running.

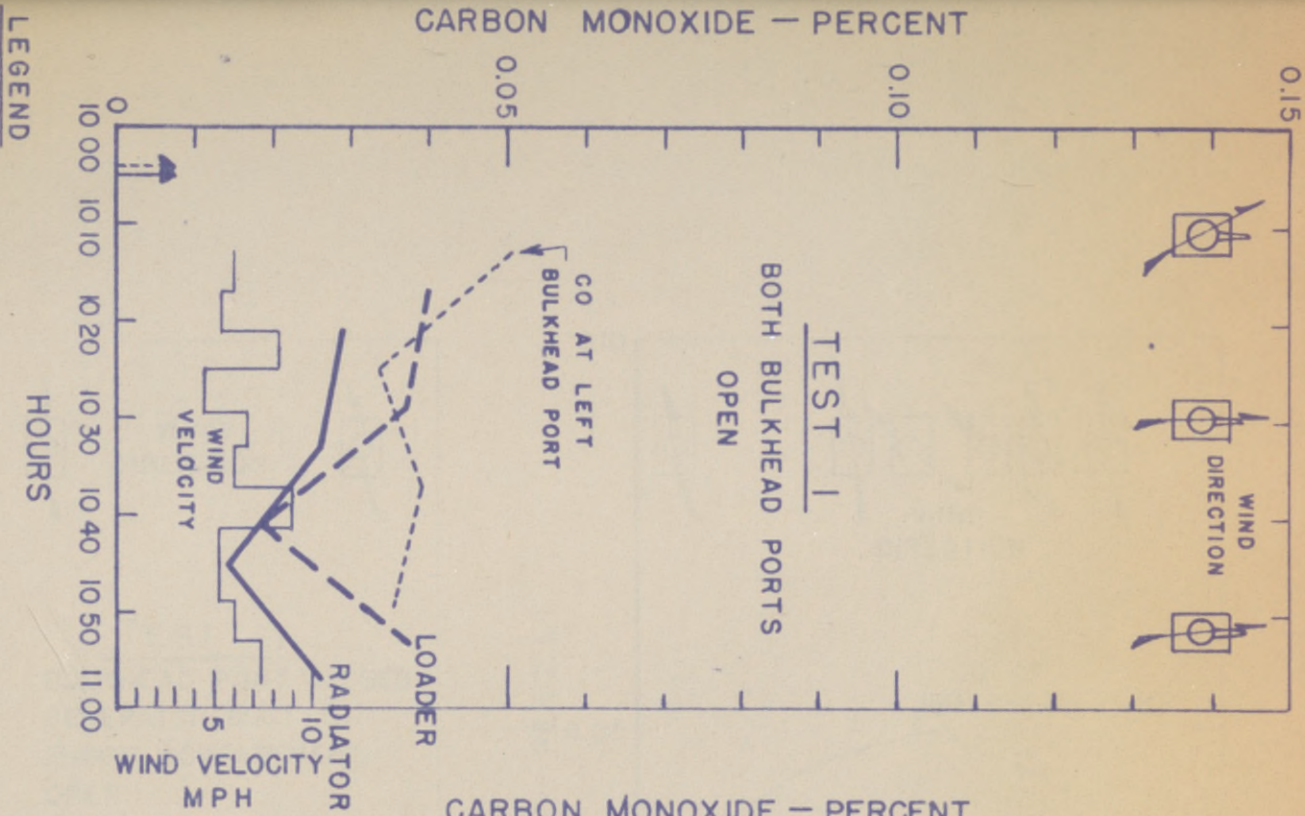
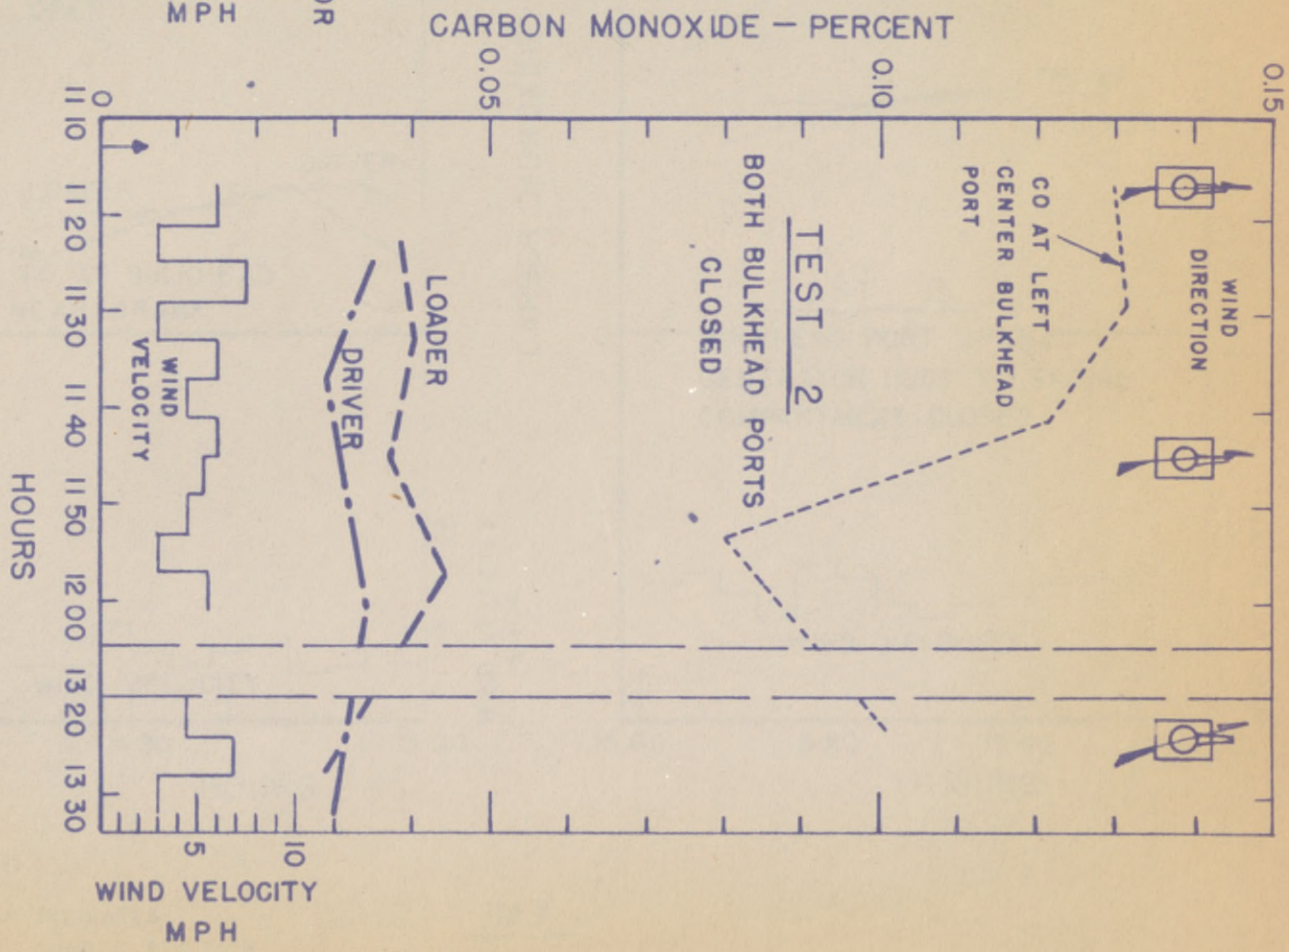
FIG. 2

(1) The carbon monoxide concentrations found in the fighting compartments of these tanks, in the present tests, could be tolerated without danger for from one-half to one hour. The data indicate that a potential hazard exists. (Figs. 2 and 3)
